Sunday River Ski Area

Inspections Pictures taken by Dan Granz – 3/29/2012

Photographer: Dan Granz – USEPA Inspector

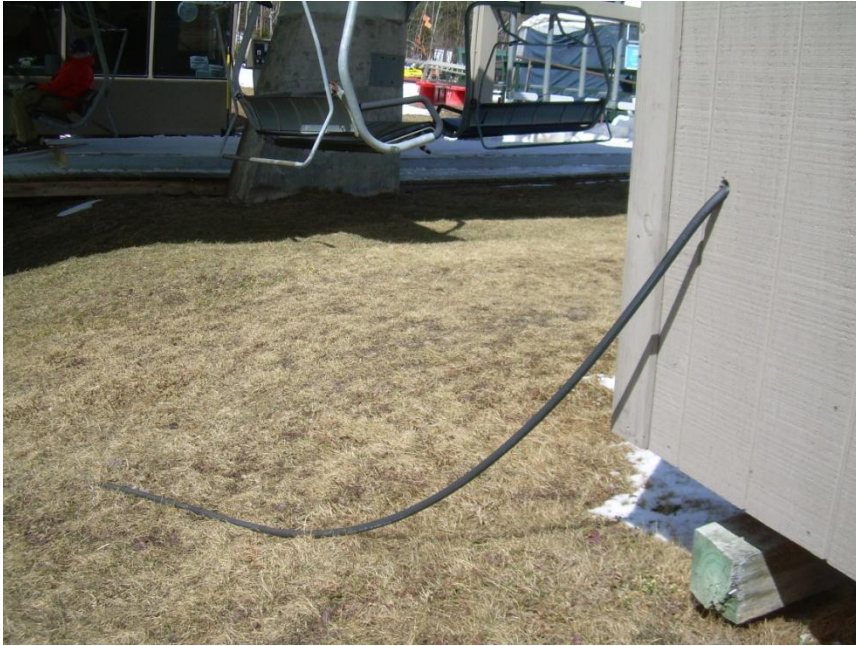
Picture 1 – Quadzilla Lift (base) SPCC plan recommended replacement of plastic fuel line not completed (03/30/2012)

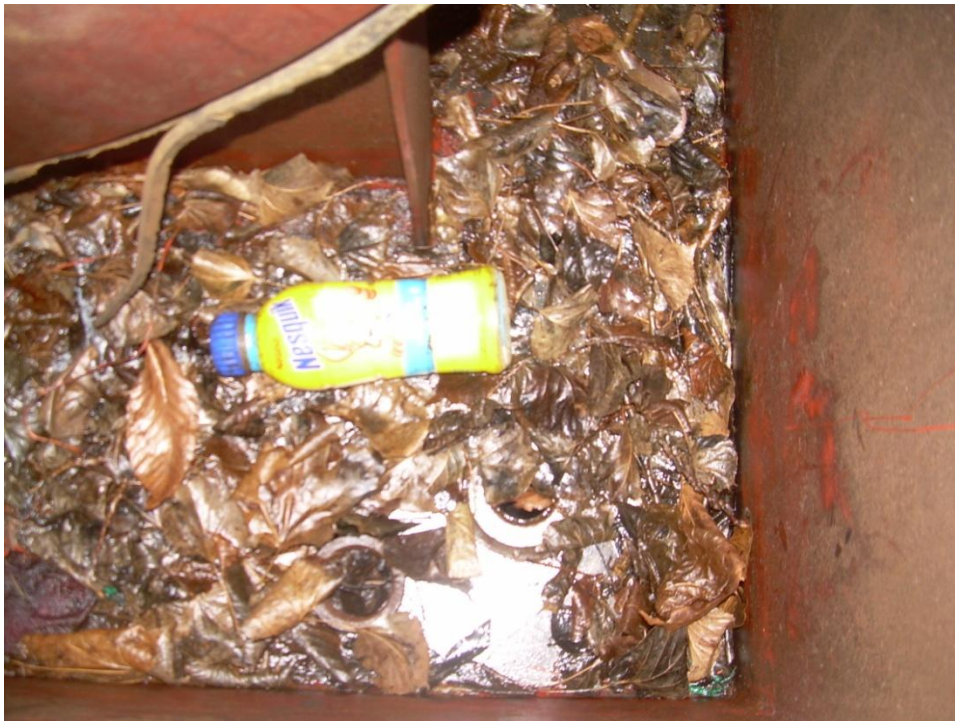
Picture 2 –Secondary containment for the 300 gallon diesel/kerosene blend CAT mobile re-fueler tank. Drainage plug missing and leaking fuel on tracks and soils. (03/30/2012)

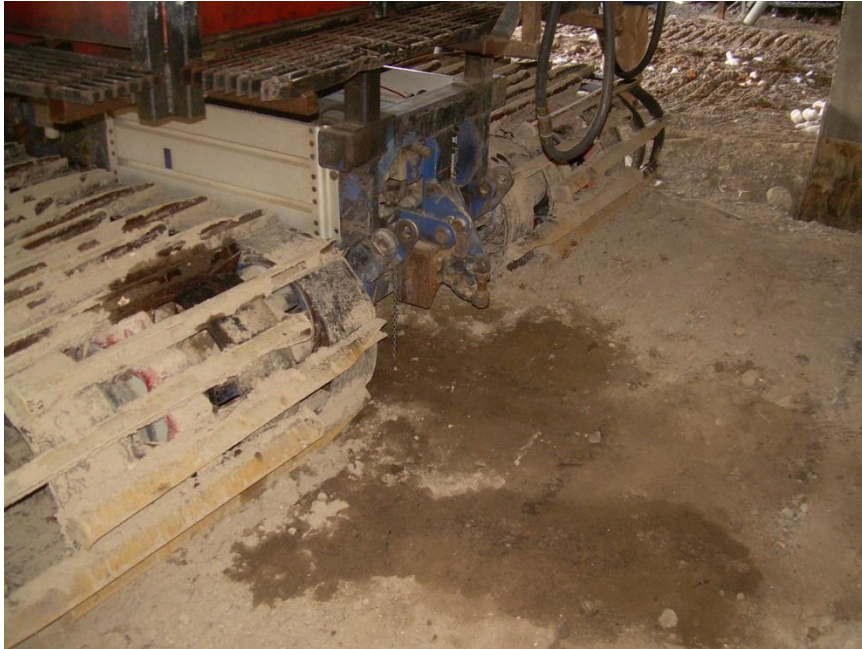
Picture 3 – CAT mobile re-fueler secondary containment leaking fuel on tracks and ground in CAT roof barn area. Leak is a result of secondary containment plug not being installed. See picture # 2 (03/30/2012)

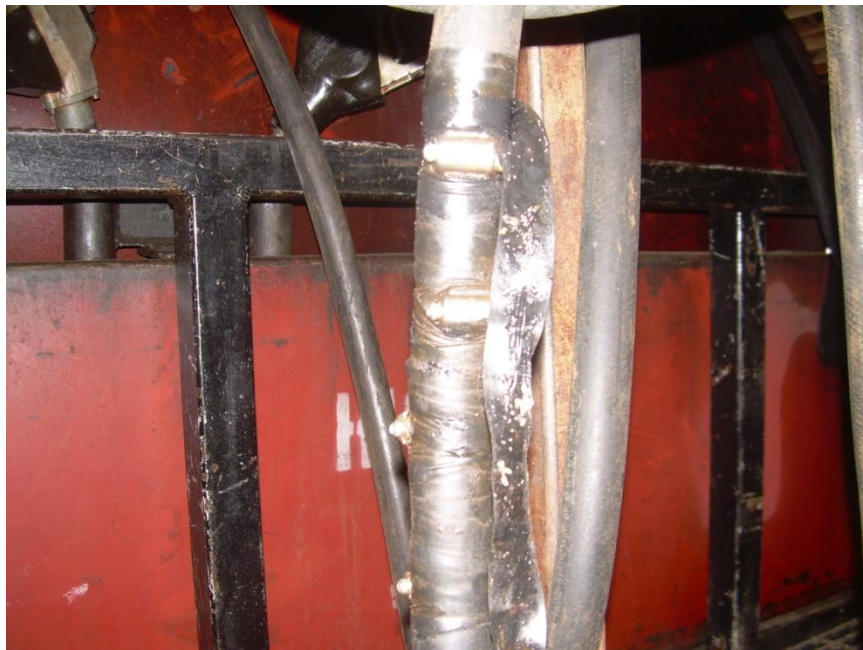
Picture 4 – Close-up of fueling hose from CAT mobile refueler. Hose is cracked and leaking and should be replaced (03/30/2012)

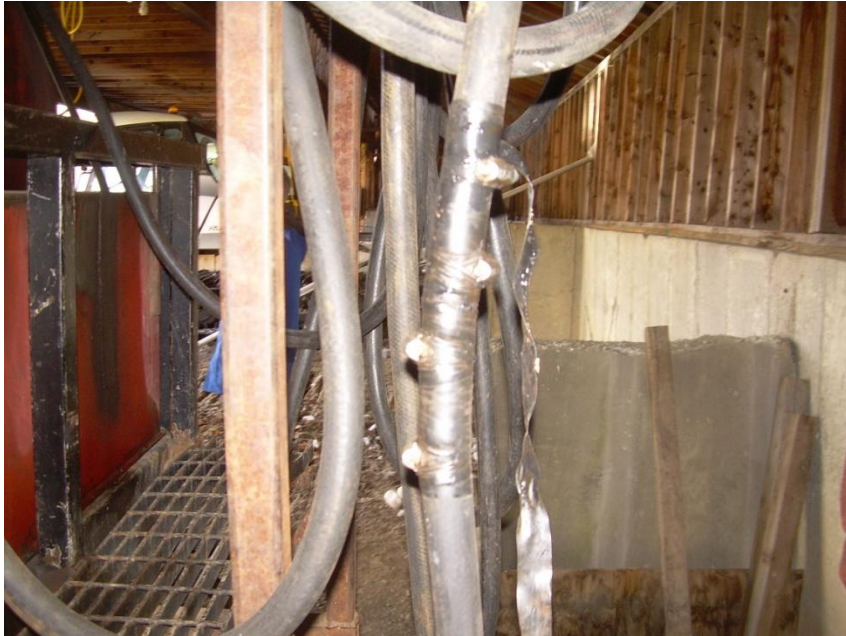
Picture 5— Additional close-up of fueling hose from CAT mobile refueler. Hose is cracked and leaking and should be replaced (03/30/2012)

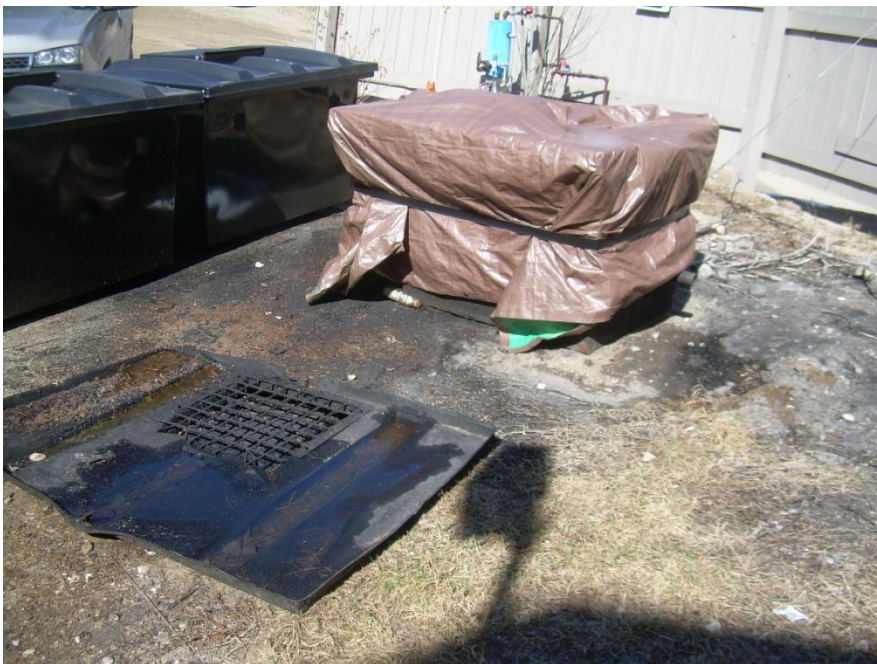
Picture 6 – 3 Waste cooking oil tanks outside with no containment and spillage on surface. Not in Plan. (03/30/2012)
